Punta Raton Beach

Slope Erosion Control

Beach Properties, San Carlos, Panama, Republica de Panama

Case Study

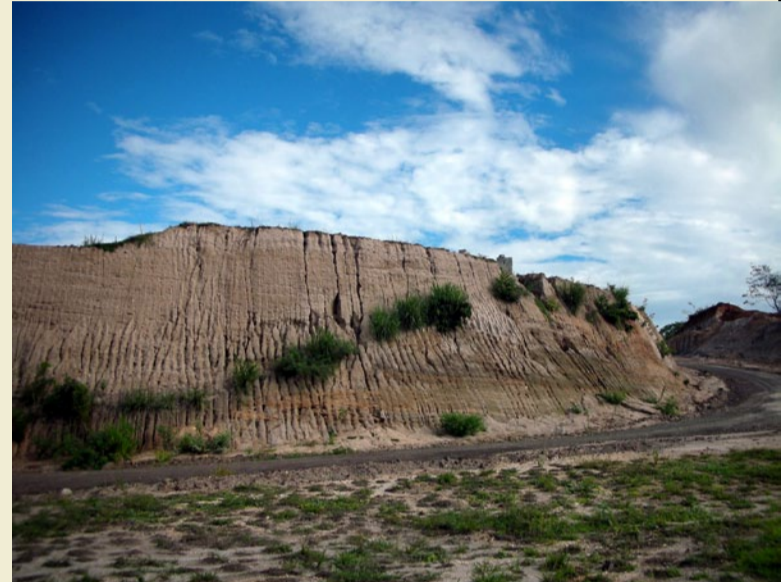
Punta Raton Beach Properties
(Pre-Envirogrid Slope Erosion Control System)

Heavy rains and wind in the coastal area as well as strong water flows coming down from the mountains during these storms have led to significant material loss on the edges of these properties. The continental sand is washing out, leaving heavily rutted and crumbling bluffs that must be protected.

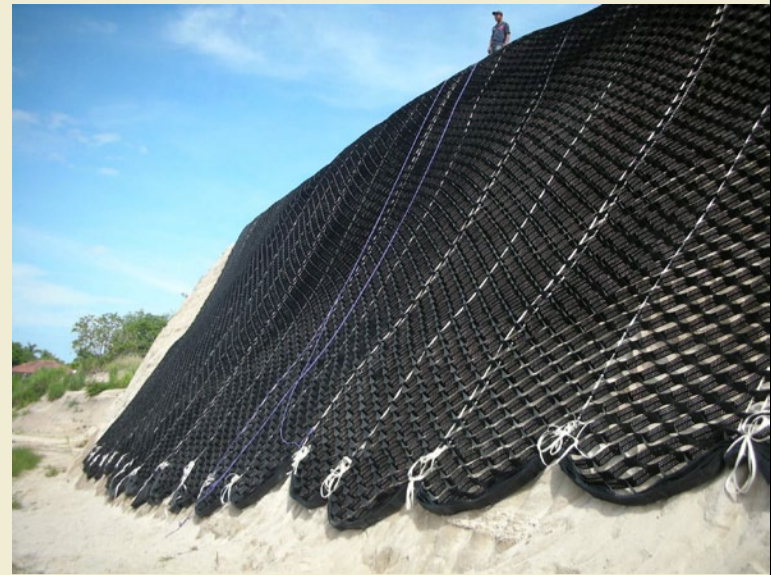
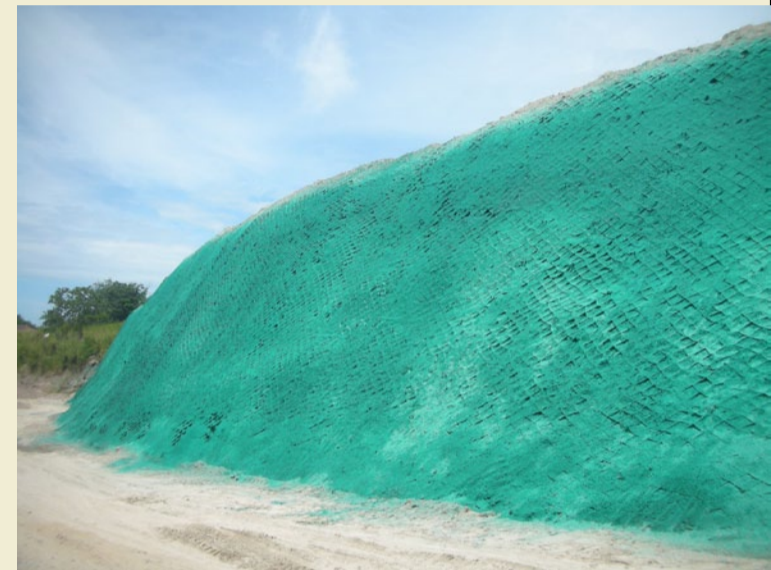
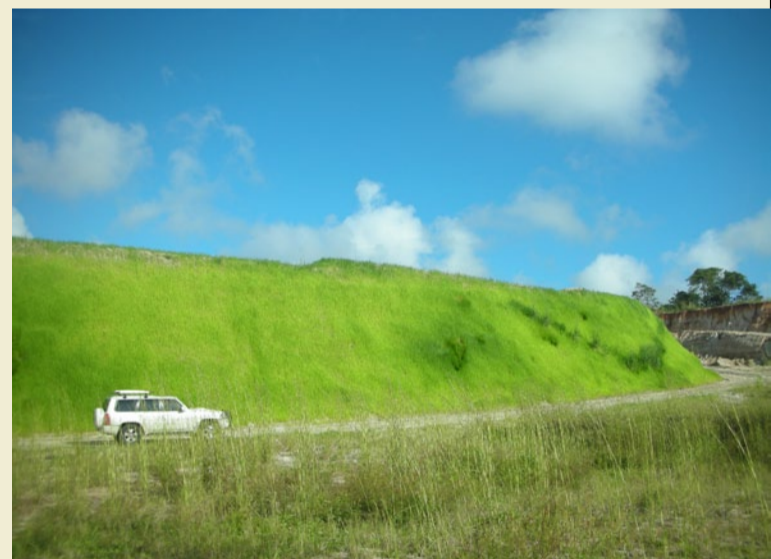
After 8 days of watering, vegetation began to take root and by 3 weeks abundant vegetation had grown on the slopes. The problem was solved. The EnviroGrid cellular confinement system impeded further erosion and confined the soils on the slope to allow grass and other vegetation to grow,
