# Punta Raton Beach

## Slope Erosion Control

Beach Properties, San Carlos, Panama, Republica de Panama

Case Study

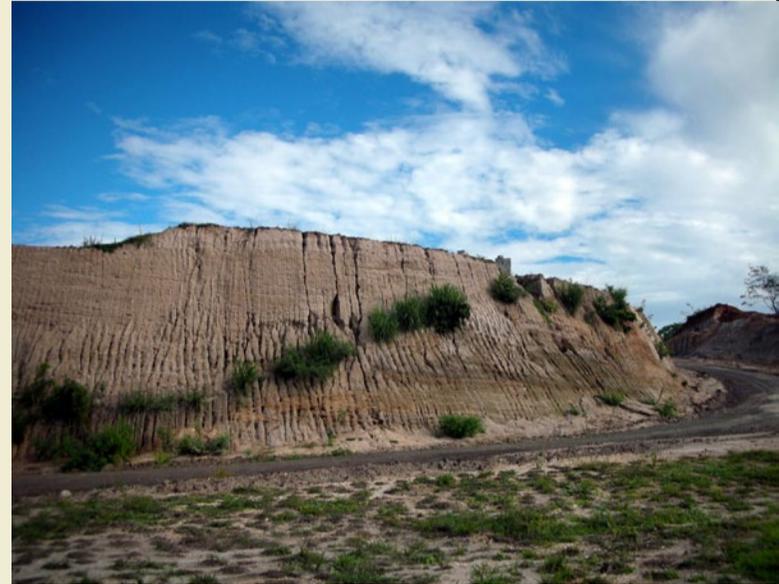
Punta Raton Beach Properties  
(Pre-Envirogrid Slope Erosion Control System)

Heavy rains and wind in the coastal area as well as strong water flows coming down from the mountains during these storms have led to significant material loss on the edges of these properties. The continental sand is washing out, leaving heavily rutted and crumbling bluffs that must be protected.

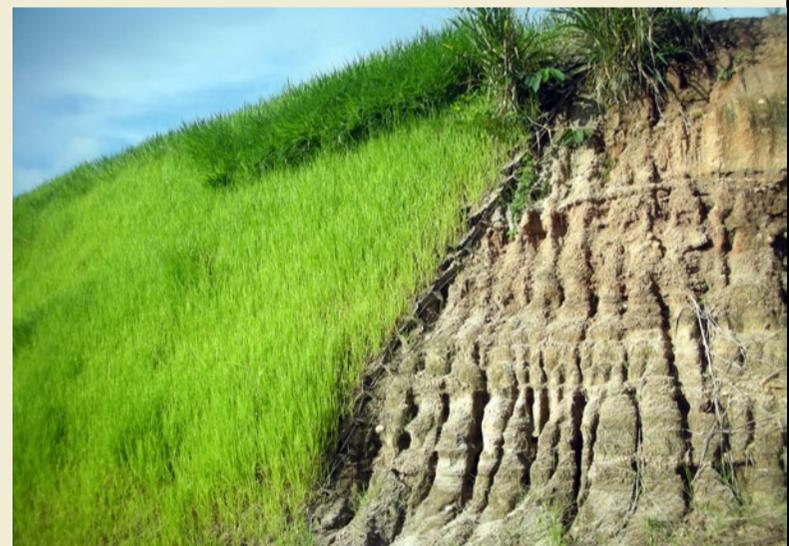
Finished Project showing termination of material  
(Left is complete, Right is original slope)

Construction began on the slopes, which were considered in critical condition at the time of the project. The soil in the area was very unstable, loose, and sandy. They proceeded to install the EnviroGrid material on the slopes, using a dead man anchor at the top connected to polyethylene tendons to support the material and prevent sliding. The cells were then filled with sandy soil. At times, this process was impossible with heavy machinery and the cells had to be filled by hand. After compacted, the slopes were hydroseeded with the root medium *Brachiaria* (by Hydro-green of Panama) and several days were given to allow the vegetation to grow.
